A Sighting in St. Augustine, Florida, Revisited

Don Snyder (St. Louis MO)

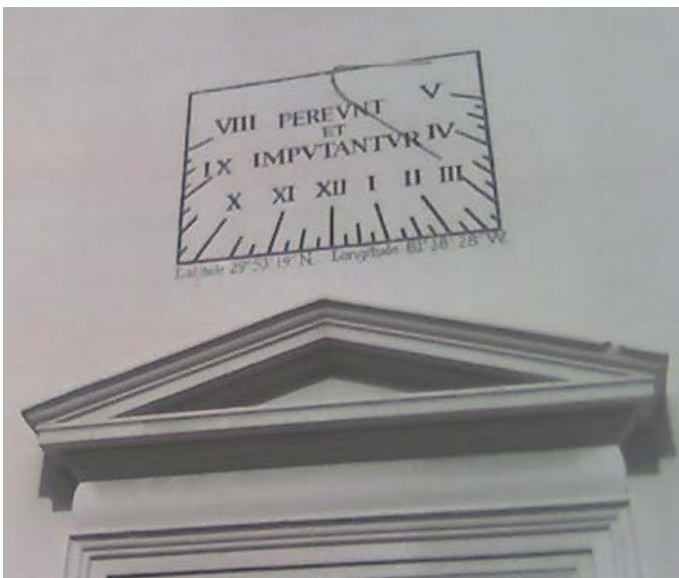
“[The following photograph of the sundial]... was taken on November 27, 2005, at about 12:30 PM EST with the sundial indicating about 3:15. The approximate three-hour discrepancy remains evident. After thinking about this some more, I may now have an explanation for the discrepancy and how to remove it. If I am correct, the repair would not be at all difficult.

Because of the apparent symmetry of the sundial about a vertical line passing through both XII and the base of the shadow-casting rod where it enters the wall, the designer of the sundial must have assumed (and may have known) that the wall faces directly South, so I will make that assumption too; it would not be very difficult to check the validity of this assumption. The rod is bent to an angle that should make it parallel to the Earth’s rotation axis. This angle [as measured from the horizontal] equals the latitude of the Basilica, which is $29^{\circ} 53'$ North, as noted on the dial itself. If the rod is bent correctly, the discrepancy occurs because the rod has been rotated, about the axis where it enters the wall, from its original position. This might have happened if the end of the rod was struck by something in the past. It would not be difficult for this to have happened if the mounting of the rod in the supporting wall is not very secure. But then, the correction would not be too difficult either. The rod would need simply to be rotated back to its original, correct position. My approach would be to choose some convenient time and then rotate the rod so its shadow indicates that time. For example, at 12:00 noon, the shadow should pass through XII. This is not quite correct since it does not account for the longitude of the Basilica and the so-called “equation-of-time,” but the error resulting from neglecting these effects is small compared to the present discrepancy. Once the rod is rotated into its correct position, a small amount of some adhesive, such as an epoxy, applied at the wall connection should hold it in place thereafter. A first step in an effort to correct the sundial would be to test whether or not the rod can be rotated easily. If not, more thought for how to proceed will be needed.”

I add an observation here, made by my friend A. Lohr of Lighthouse Pt., Florida, after my letter was written – a hurricane in the vicinity of St. Augustine might reasonably have resulted in a heavy piece of airborne debris striking the gnomon, knocking it out of alignment. Hurricanes are common in Florida, and this is a conjecture made plausible by all the havoc caused in the 2005 hurricane season.

After receiving the letter, I made two internet queries. The first was for dates after 1894 when hurricanes hit in the vicinity of St. Augustine. One occurred in Sept., 1964, with winds in excess of 110 mph and another in Oct., 1968, with 80 mph winds. One of these hurricanes may have caused the displacement of the gnomon, but there is no way to know for certain. A second internet search has so far not yielded a picture of an Oxford University sundial that is similar to the one in St. Augustine.
